Metal Roof Restoration

- Category:** Waterproofing & Insulation
- Customer:** Residential Building
- Project:** Roofing repair and installation of a spray polyurethane foam-based (SPF) roof system.
- Products:** DuraTite® CC2.5, DuraTite® 1395

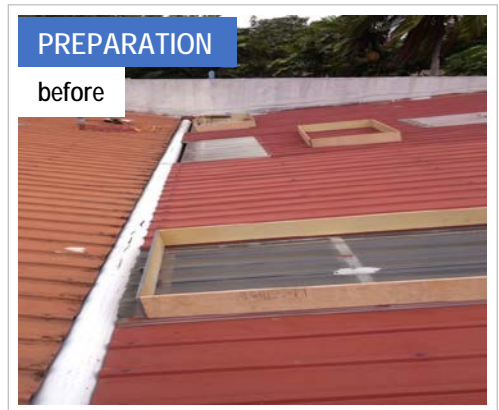
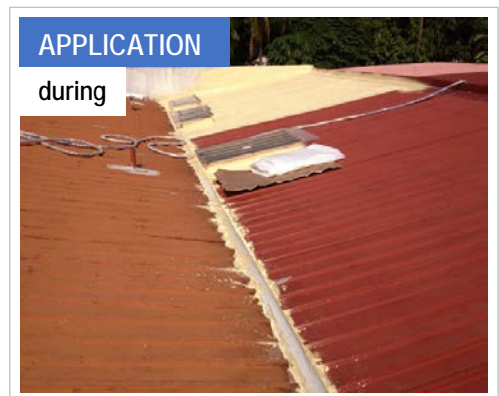
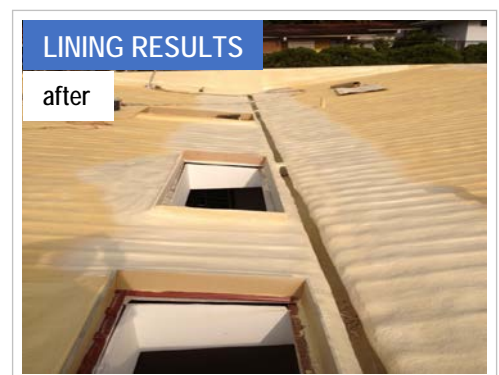
The roof was initially cleaned by pressure washing the metal substrate to remove any loose paint, mold, grime, dust and dirt, creating a clean surface for coating.

Next, the 4-inch PVC piping was connected to the original drain pipe to reach across the entire canal. Skylights were raised 10 inches from the roof and replaced with polycarbonate. DuraTite CC2.5 was then spray-applied at 1 inch thick covering the entire roofing structure.

DuraTite 1395 silicone coating was finally fluid-applied over the SPF. The reflective properties of the coating play an essential role in keeping the building's internal temperatures low. In addition, the white silicone coating helps distribute heat evenly across the surface of the roof by effectively scattering sunlight.

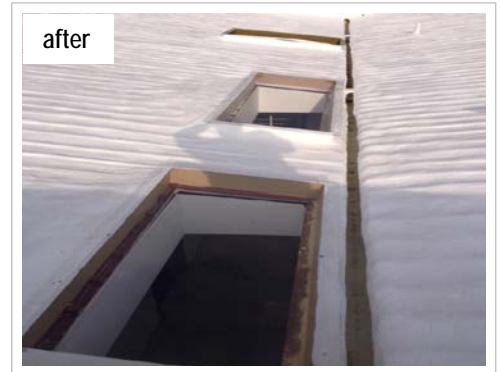
Rhino Linings® products provided a cost-effective repair solution. The DuraTite® Roofing System extended the life of the existing roof, remedied the drainage issue and provided insulation and durability the customer required. According to the property owner, the new SPF roofing system has exceeded expectations over the three years it has been in service. The roof does not require maintenance and the in-home temperature has dropped 25%, keeping inhabitants cool and comfortable.
